RHIC QUENCH PROTECTION DIODE RADIATION DAMAGE*

A. Drees[†], O. Biletskyi, D. Bruno, A. DiLieto, J. Escallier, G. Heppner,
C. Mi, T. Samms, J. Sandberg, Brookhaven National Laboratory, Upton, NY, USA

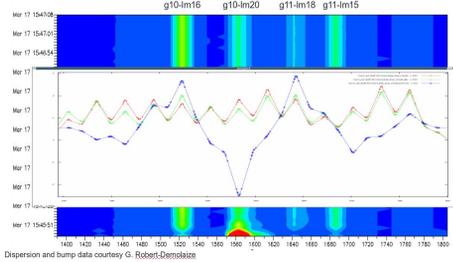
Figure 4: Several minutes of loss map data from the blue arc 10 area with the orbit bump and dispersion function inlaid.

amplitude accounts for a few 10 rad/h continuous loss rate at certain pronounced locations (green color). The names at the top indicate local loss monitors at these locations. At the time of the failure, these losses together with a series of single large loss events such as prefires, accumulated to a dose of about 11 kGy at the edge of the beam pipe, i.e. the location of the QPD. This number is an extrapolation from integrated loss monitor measurements at the outside of the cryostat and activation measurements of the damaged diode after its removal from the cryostat of B10-D19. Due to the elapsed time between failure and activation measurement (≈ 3 weeks) as well as the different locations of loss monitors vs. QPDs, this value is only an approximation. There is no reliable activation measurement available from the second event since RHIC continued to operate and it took more than 4 months between failure and removal of the diode. However, judging from integrated loss monitor data from the area of Y7-D6, it appears that the accumulated dose in run17 at the time of failure was significantly less than for B10-D19 in the year before. However, as stated ear-

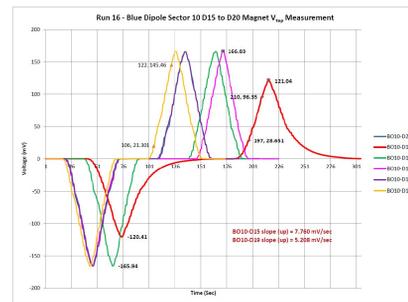
In run16, once we knew there was a problem within one voltage tap (VT), the individual magnets were measured in-situ in the tunnel since it cannot be determined from the outside which of the 6 magnets of one VT has an issue. Figure 5 shows the results of the voltage measurements of all diodes in the VT that hosts B10-D19 (red trace). It clearly identifies B10-D19 as the QPD with a problem. Once it was

Figure 5: Voltage measurements of the 6 diodes sharing the same VT as B10-D19. All diodes show the same characteristics and amplitude, except for B10-D19 with a reduced amplitude and slope.

determined which diode was damaged, this RHIC sector was warmed up, the cryostat was opened and the diode replaced followed by a cool-down. Since RHIC could still be operated even with the damaged diode in place in run17, the offending assembly was removed once we had warmed up both rings after the run. Figure 6 shows the two damaged diodes from the two runs side by side. The top of each wafer in the picture

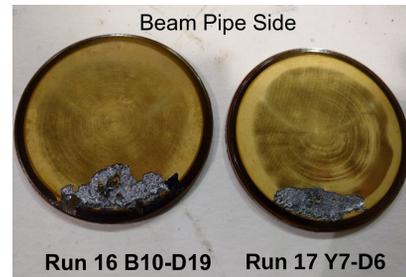
Figure 6: Damaged silicon wafers after removal from the tunnel without their assemblies.

would be the closest point to the beam pipe, the damaged areas are farthest away from it. This lead to the hypothesis that radiation damage to the silicon wafer prior to the magnet quench had altered the forward voltage the most in the area close to the beam pipe and the least far away, thus creating a gradient of the forward voltage across the diameter of the wafer. When the magnet quenched and the diode started

to conduct current, the gradient caused current crowding in the area that became conductive first, i.e. far away from the source of radiation thus causing the burnt silicon. Alternatively, we discussed the possibility that a single event upset could be sufficient to cause current crowding without a history of prior irradiation. At this point we do not have enough data to disprove one or the other explanation. In an attempt to find other potentially radiation altered or damaged diodes, a total of 148 blue and 153 QPD forward voltages were measured in the tunnel while the magnets were still cold. Figure 7 shows the distribution of these measurements. Both rings give rather similar results, with forward voltages

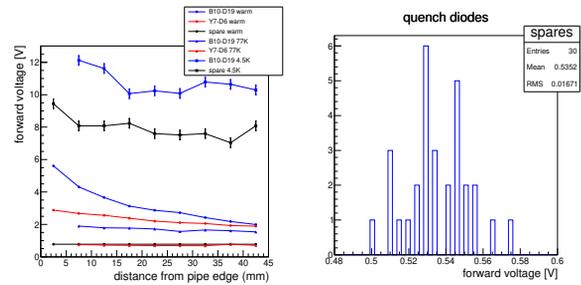
Once the damaged diodes were removed from the tunnel they were available for test bench measurements at room temperature, at 77 K and 4.5 K. In order to measure the gradient across the wafer surface along the virtual line between pipe edge and burnt area, the two diodes and one spare diode were lacerated into 5 mm x 5 mm dice by using a laser¹. When the individual dice were sufficiently electrically isolated from each other, we could measure the individual die's forward voltage one by one. Figure 8, left, summarizes the results of these measurements. Each data point corresponds to one die and is separated by 5 mm from its neighbor. "0" refers to the closest point to the beam pipe edge, however there are still a few additional millimeters between the edge of the wafer and the actual beam pipe. The gradient is clearly present at room temperature and vanishes at 77 K. The 4.5 K data has a significantly larger error and scatter, thus making it difficult to determine a gradient. B10-D19 demonstrates a larger effect, consistent with its history of integrated dosage being larger than that of Y7-D6. In addition, the room temperature forward voltage appears shifted to larger values for the two damaged diodes if compared to the spare. Since the in-situ measurements at 4.5 K of the diodes showed no correlation

Figure 8: Left: die-by-die forward voltages for two damaged and one spare diode at various temperatures. Right: overall forward voltages of all available spare diodes at room temperature.
